# Manhole Inspection Summary

Manhole # S290\_\_019MH

Insp Date: **5/14/09 9:15 AM**

**Location** Address: **1099 SCOTT ST**

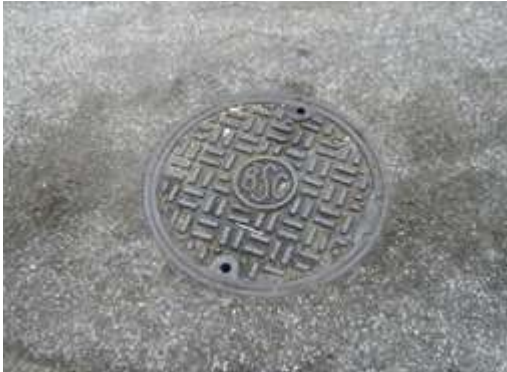
COVER PIC

**Cover** Shape: **Circular** Diameter: **26** (in.) Length: **0** (in.) Dist A/B Grade: **0** (in.)

Type: **Sanitary** Condition: **Sound** Cover Material: **Cast Iron**

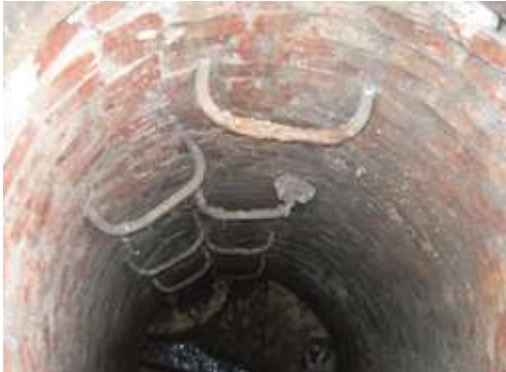
MH Steps

**Steps** Count: **8** Missing: **0** ☒ **Corroded**

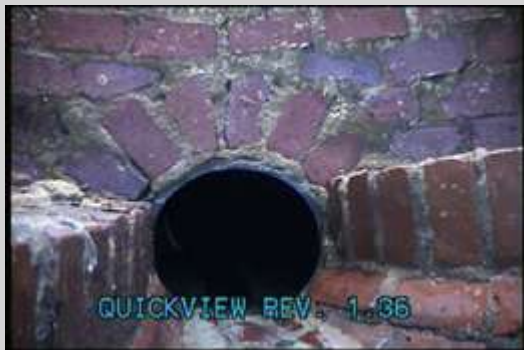
12 O'Clock Outflow

8 in. Circular Gravity Sewer  
Pipe Out @ 12 O'Clock

Pipe Height: **8.4** (in.) Rod and Bar (Angled)  
Pipe Material: **Clay** ☐ Pipe Lined  
Invert Depth: **11.84** (ft.) Flow Characteristics: **Fast**  
Deposits: ☒ None ☐ Mud ☐ Sludge ☐ Debris ☐ Grease  
Silt Depth: **0** (in.) Deposits Extent:  
Infiltration: **None** Pipe Seal Cond: **Sound**

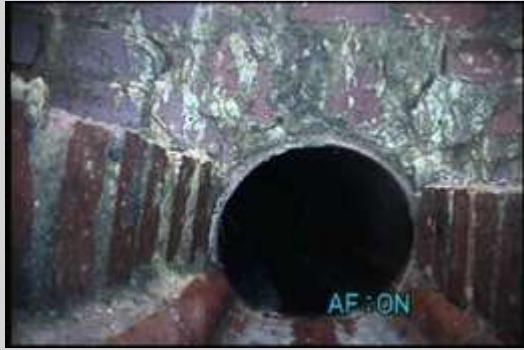
6 O'Clock Inflow

8 in. Circular Gravity Sewer

Pipe In @ 6 O'Clock

Infiltration: **None** Pipe Seal Cond: **Sound**
